**Next month:
Building and installing
the 20V turbo engine**

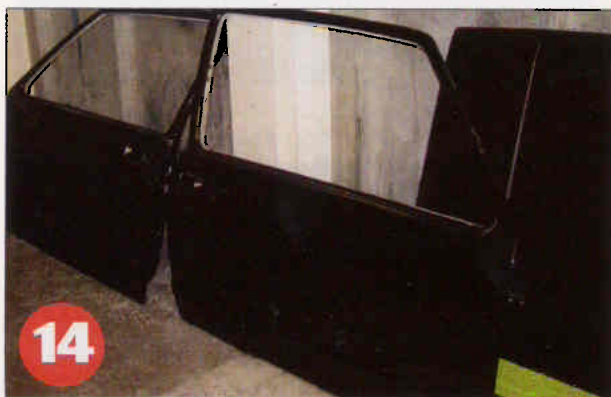
14) The doors and bumpers, hatch and bonnet were all shotblasted off the car before any prep stages and then wet sanded after to a mirror shine

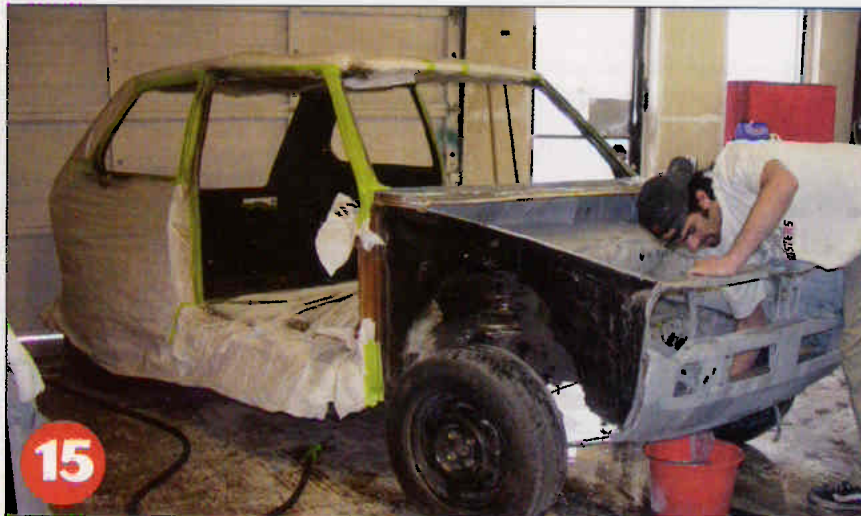
15) Here's the 'shell' being prepped for its final primer sealer and paintwork
